UNDERWATER BRIDGE INSPECTION REPORT

STRUCTURE NO. 57518
CSAH NO. 3
OVER THE
RED LAKE RIVER
DISTRICT 2 - PENNINGTON COUNTY

PREPARED FOR THE
MINNESOTA DEPARTMENT OF TRANSPORTATION
BY
COLLINS ENGINEERS, INC.
JOB NO. 5221 (CEI 9A)

MINNESOTA DEPARTMENT OF TRANSPORTATION
UNDERWATER BRIDGE INSPECTION

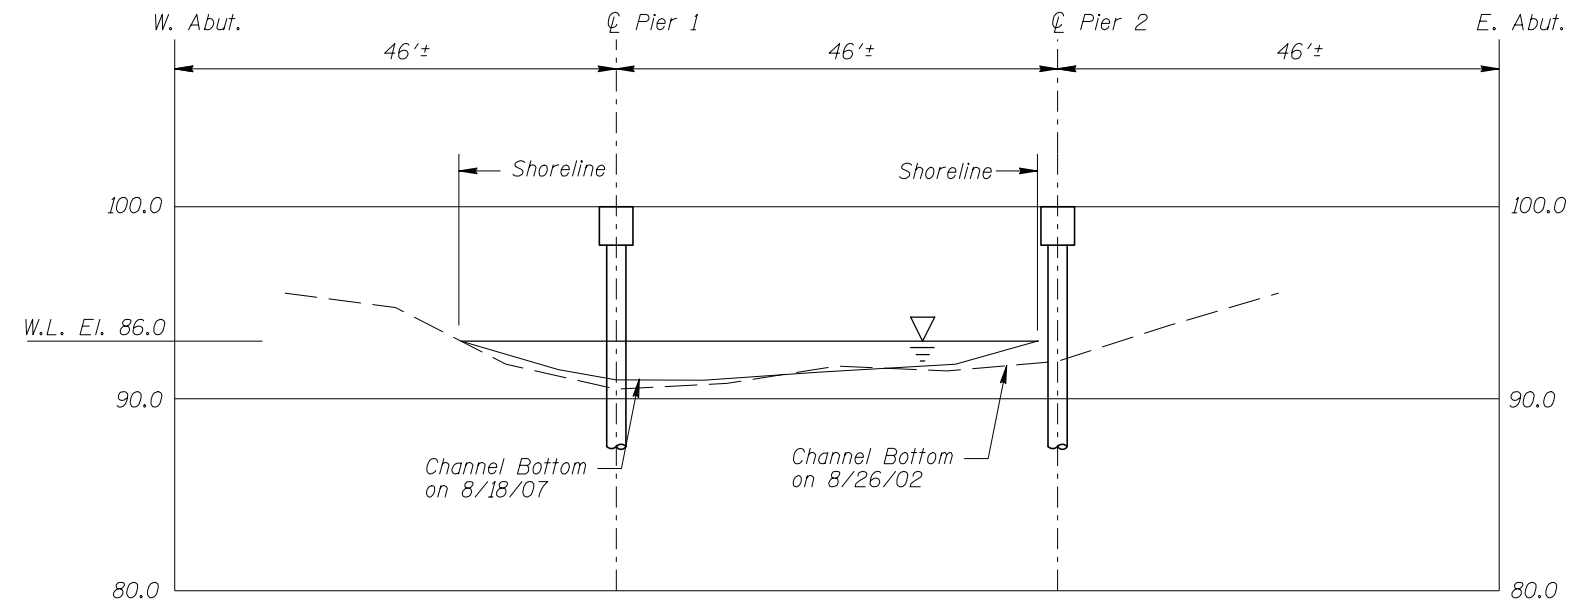
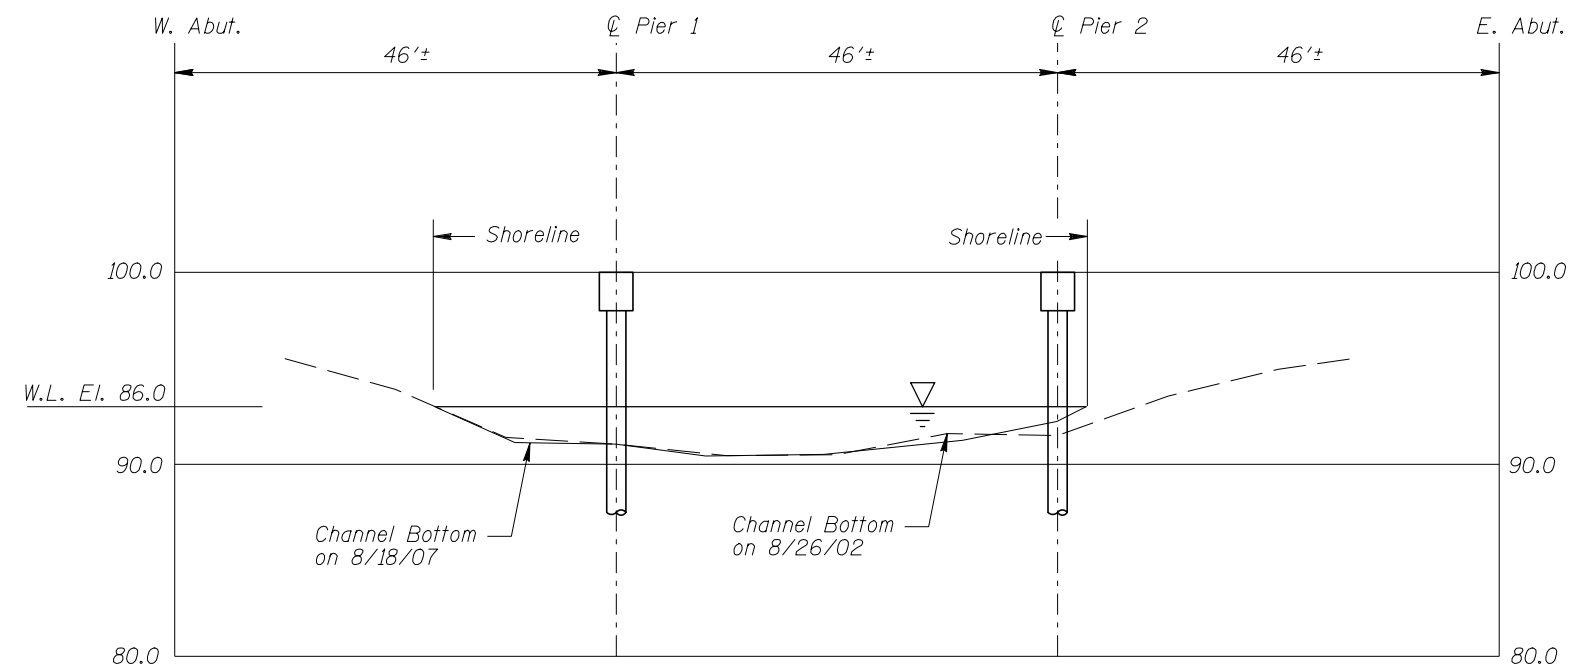
INSPECTION AND SOUNDING PLAN

- The channel bottom material around Piers 1 and 2 consisted of sand with 12 inches of probe rod penetration.
- A light to moderate accumulation of 1-foot-diameter and smaller timber debris and organic material was observed around Piles A through D at Piers 1 and 2.
- The steel pipe piles exhibited coating failure and random areas of minor surface corrosion with no appreciable loss of section over approximately 50 percent of the surface area from 5 feet below the top of the piles to the channel bottom.
